Inspection Report

This inspection performed in accordance with current "Standards of Practice" of the American Society of Home Inspectors.

This inspection report prepared specifically for:

Debra Ahlden
2713 Carrelton Dr.
Champaign, IL 61821

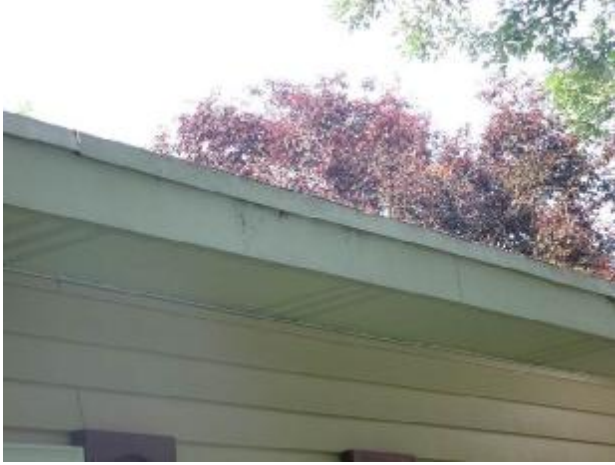
Roof # R1

19 This house does not have a guttering system. Although this house is built on a slab, gutters are recommended for all homes. A properly working gutter system will help divert water away from the foundation which will help extend the life expectancy of the foundation. (see photo 1).

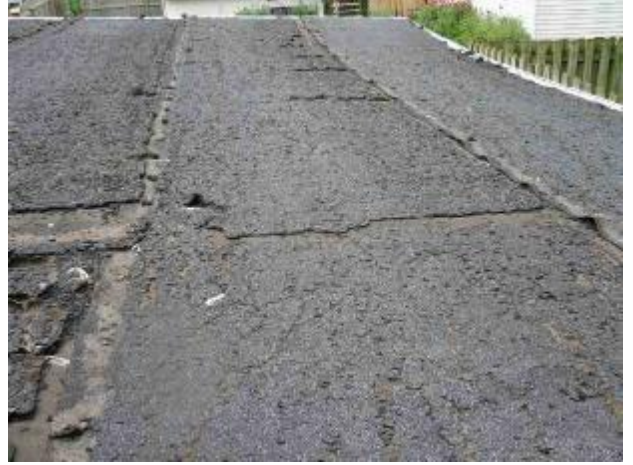
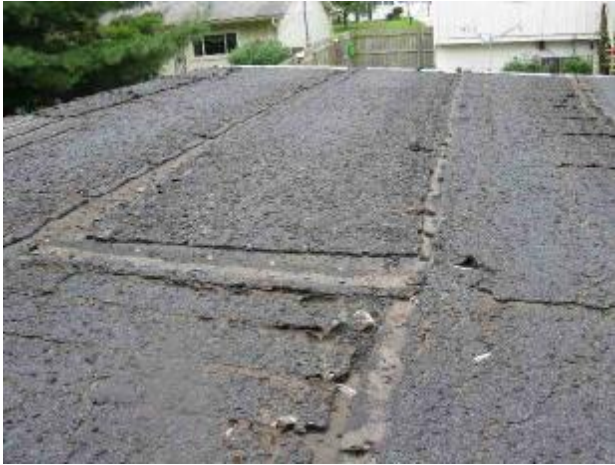
Roof # R2

The shed roof is at the end of its useful life and needs to be repaired or replaced. It's recommended a roofing professional evaluate and make the necessary corrections. (see photo 2 & 3).

The shed roof is at the end of its useful life and needs to be repaired or replaced. It's recommended a roofing professional evaluate and make the necessary corrections.

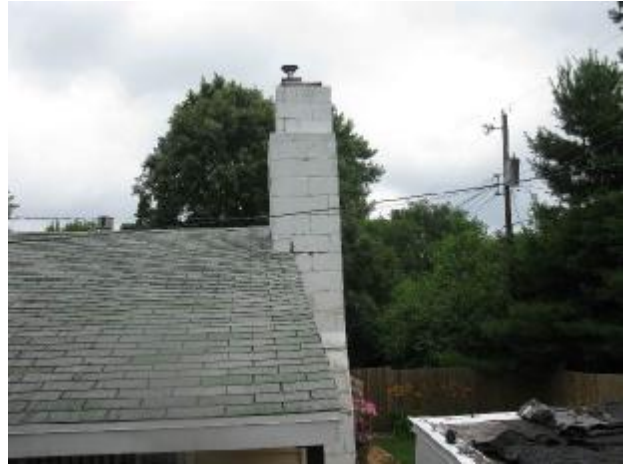
Roof # R4

Evidence of cracking and deteriorated mortar at chimney. Repair chimney. (see photo 4).

Evidence of cracking and deteriorated mortar on chimney. It is recommended the chimney be evaluated and necessary corrections be made.

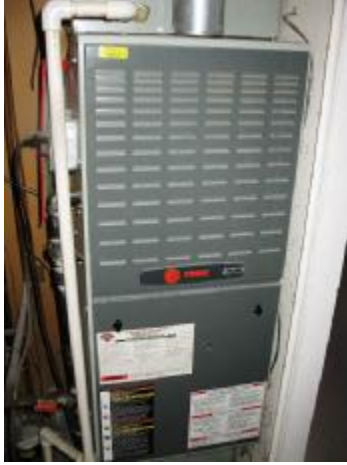
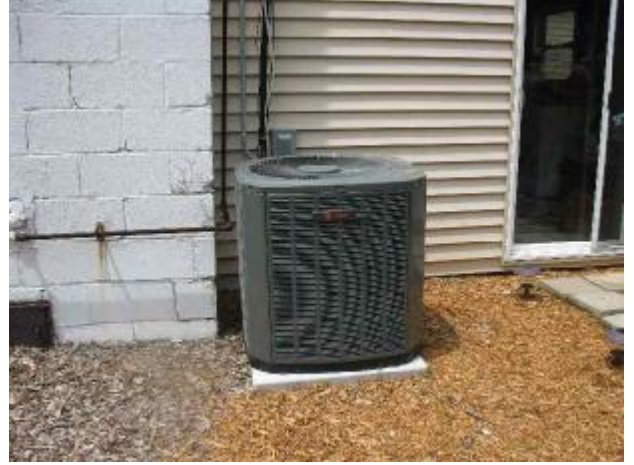
- 24 It is recommended a licensed HVAC professional evaluate and service the heating and cooling units on a yearly basis. (see photo 1 & 2).
- The disposable furnace filter is dirty and needs to be replaced.

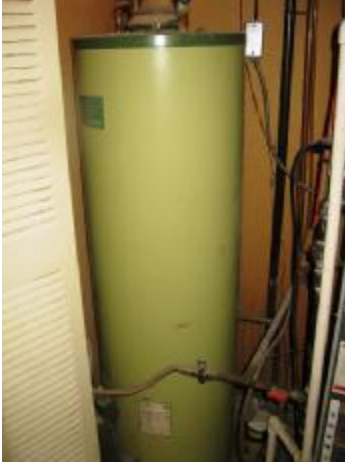
P1

20 Keep in mind the advanced age of the water heater. Unit is approaching the end of its expected useful lifespan. Budget for replacement soon. (see photo 1).

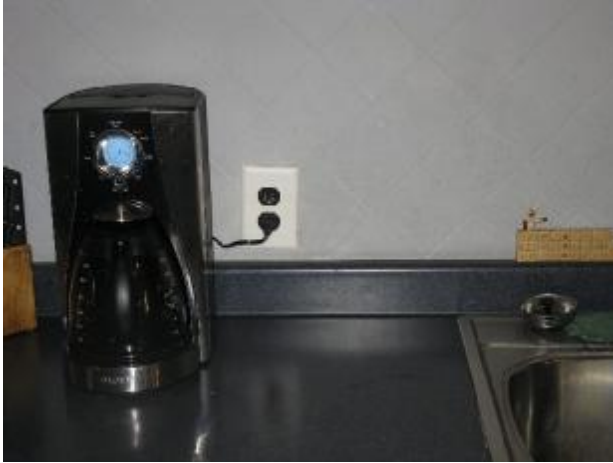
Kitchen & Laundry # K1

26 We recommend installation of GFCI outlets in kitchen as a safety upgrade. (see photo 1).

We recommend installation of GFCI outlets in kitchen and master bathroom as a safety upgrade. An electrician should evaluate and make the necessary corrections.

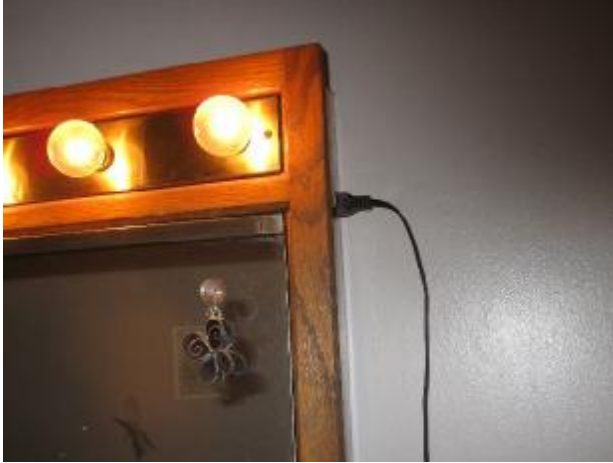
B1

14 We recommend installation of GFCI outlets in master bathroom as a safety upgrade. (see photo 1).

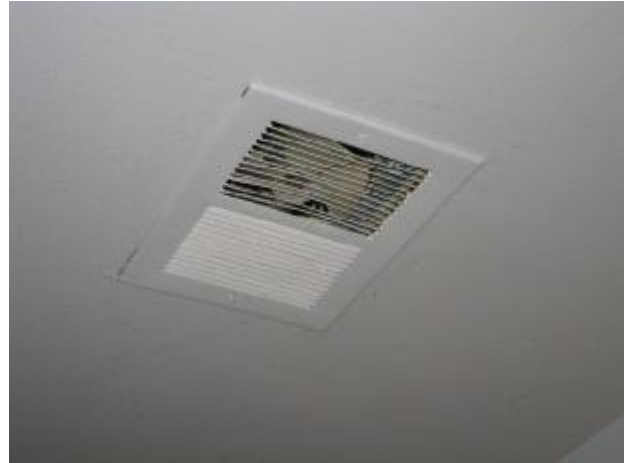
B4

Bathrooms are required to have either an operable window or a vent fan for ventilation. The master bathroom has neither. Install or repair the fans. (see photo 4).

Bathrooms are required to have either an operable window or a vent fan for ventilation. The master bathroom has neither. It is recommended a ventilation fan be installed in master bathroom.
